Manhole Inspection Summary

Manhole # **S13C__029MH**

Insp Date: **1/28/08 12:06 PM**

Location Address: **541 FRANKLIN ST**

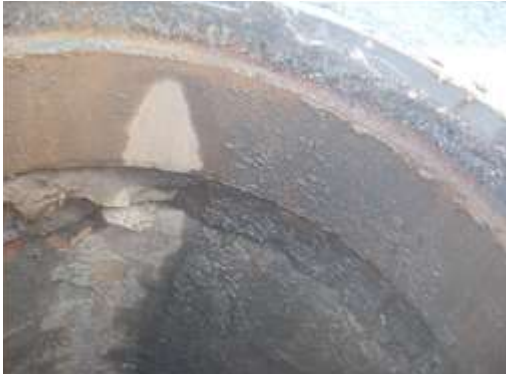
Defect 2

Condition: ☐ Sound ☐ Cracked ☐ Root Intrusion ☐ Loose Brick ☒ **Deteriorated**

CHIMNEY DETERIORATION

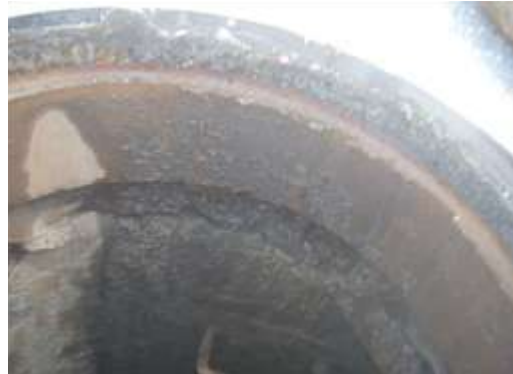
Defect 1

Infiltration: ☐ None ☒ **Joint** ☐ Cracks ☐ Mortar ☐ Roots ☐ Wall

CHIMNEY INFILTRATION

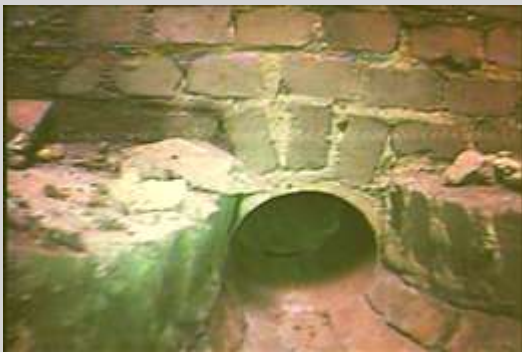
12 O'Clock Outflow

8 in. Circular Gravity Sewer
Pipe Out @ 12 O'Clock

Pipe Height: **8.4** (in.) Rod and Bar (Angled)
Pipe Material: **Clay** ☐ Pipe Lined
Invert Depth: **6.25** (ft.) Flow Characteristics: **None**
Deposits: ☒ None ☐ Mud ☐ Sludge ☐ Debris ☐ Grease
Silt Depth: (in.) Deposits Extent:
Infiltration: **None** Pipe Seal Cond: **Sound**

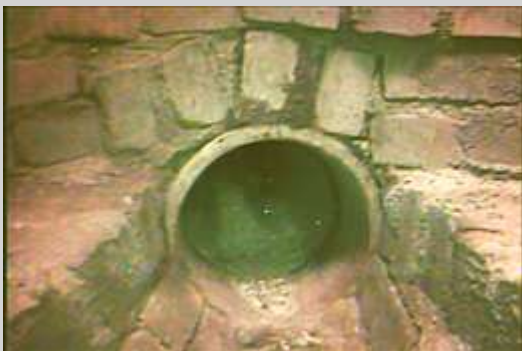
3 O'Clock Inflow

8 in. Circular Gravity Sewer
Pipe In @ 3 O'Clock

Pipe Height: **8.4** (in.) Rod and Bar (Angled)
Pipe Material: **Clay** ☐ Pipe Lined
Invert Depth: **5.51** (ft.) Flow Characteristics: **None**
Deposits: ☒ None ☐ Mud ☐ Sludge ☐ Debris ☐ Grease
Silt Depth: (in.) Deposits Extent:
Infiltration: **None** Pipe Seal Cond: **Sound**

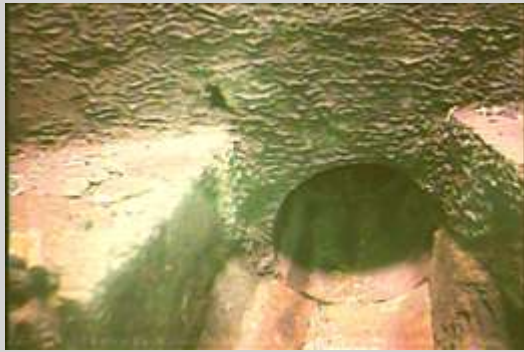
6 O'Clock Inflow

6 in. Circular Gravity Sewer

Pipe In @ 6 O'Clock

Deposits: ☒ None ☐ **Mud** ☐ Sludge ☐ Debris ☐ Grease

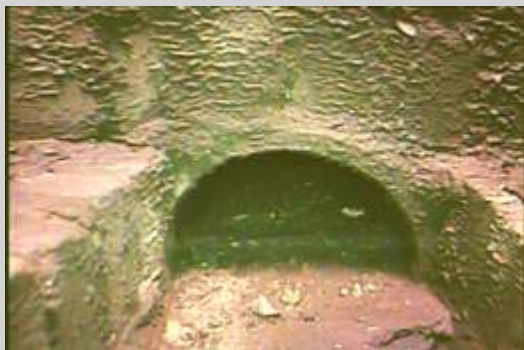
9 O'Clock Inflow

8 in. Circular Gravity Sewer

Pipe In @ 9 O'Clock

Invert Depth: **5.37** (ft.) Flow Characteristics: **Slow**

Deposits: ☐ None ☒ **Mud** ☐ Sludge ☐ Debris ☐ Grease

Silt Depth: **4** (in.) Deposits Extent: **Medium**
